To Clean or Not to Clean: Managing Fouling on Boat Hulls

**UCCE-SD/UC-SGEP Fact Sheet 2011-3
February 2011 (rev. September 2011)**

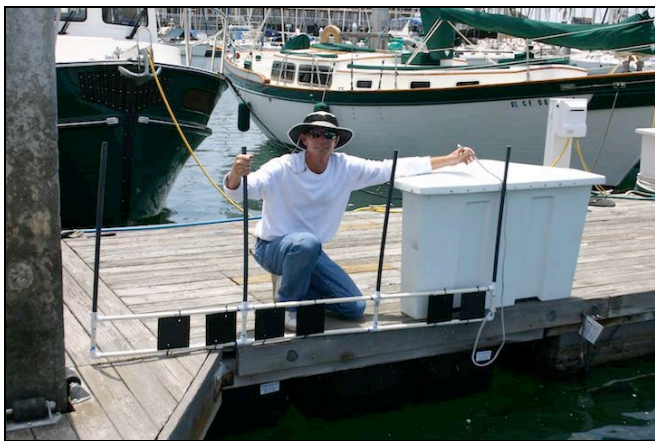
Experimental panels were submerged at local boat docks. Each panel had a base gel-coating. On top of the gel coating one of the following products was applied: copper antifouling paint; nontoxic ceramic-epoxy; or nontoxic, siliconized epoxy. We had three cleaning treatments: continuously cleaned; cleaned once; and not cleaned (new).

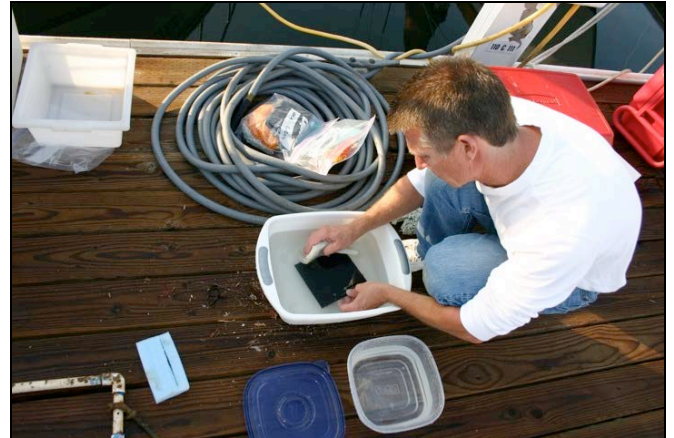
Before each cleaning, we rated the fouling present on each panel and the cleaning tool and effort required to remove it, using a five-point scale developed with the CPDA.^{2,5} At the end of the fourth month, all panels were cleaned and the levels of fouling growth, cleaning tool and cleaning effort were recorded along with the weight of the removed fouling growth.
